Safe use of bed rails

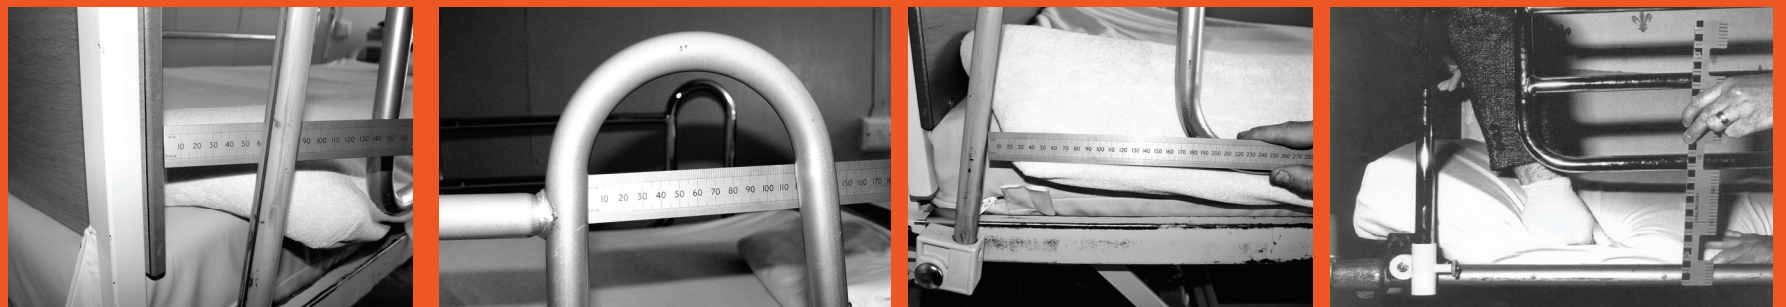
'Third party' bed rails, as photographed below, are not model specific and fit a wide range of beds. The principles set out below apply to all types of bed rails.

Bed rails should be fitted so that the gap between their end and the headboard is less than 60mm or greater than 250mm.

All gaps between the rail bars for adults must be 120mm or less and for children 60mm or less.

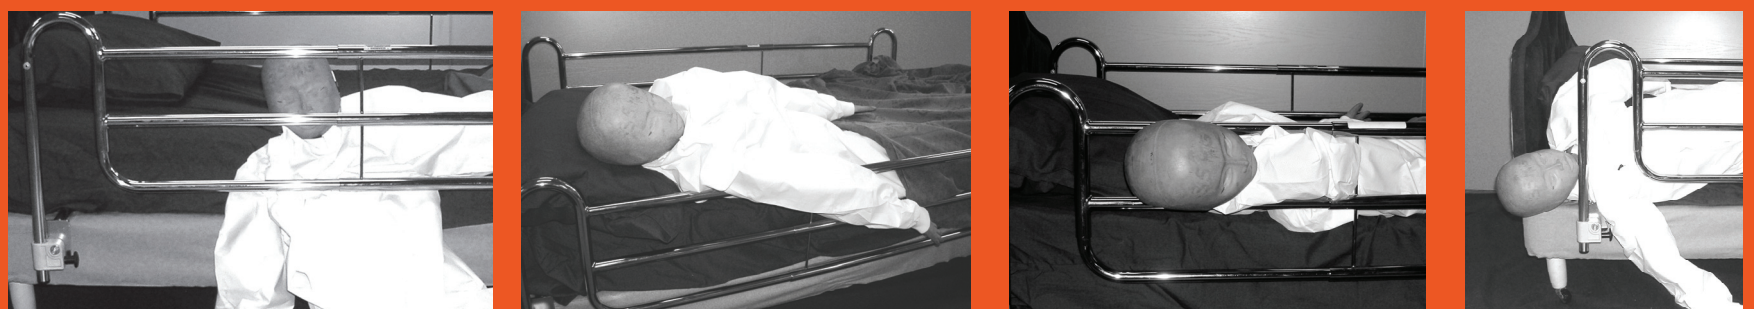
Most of the deaths caused by bed rails could have been avoided if thorough risk assessments of the bed occupant, the bed and the bed rail combination had been carried out.

MHRA investigations have also shown that many serious and fatal incidents with bed rails have been caused by a lack of maintenance.

Bed rails must be inspected on a regular basis to ensure they are in good condition.

- Gaps that could cause head, neck or chest entrapment when the mattress is compressed or between the end of the bed rail and the headboard or footboard.
- Using bed rails which are not compatible with the bed base.
- Using insecure fittings that let the bed rail drop down or move away from the side of the bed.
- Using bed rails that have not been maintained regularly.
- Bed rails with parts missing.
